# CAAP Annual Report

Project Title: *Patch and Full-Encirclement Repairs for Through-Wall Defects*

Prepared by: *The University of Tulsa*

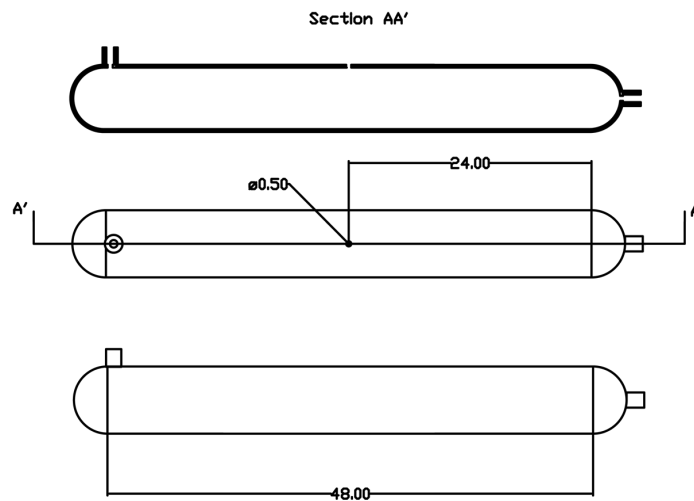
**Figure 1: Schematic of the small scale test specimen used in this project. Dimensions are in inches and pipe is a standard ASTM A106B schedule 40 pipe with a 6 in nominal diameter.**

The small-scale test program was the first experimental test that was to be completed for this research project. Each of the participating companies was to repair six pipes with three full encirclement repairs and three patch type repairs. A dimensioned drawing of the test specimen is shown in Figure 1. The specimen was basically a four-foot-long section of 6 in A106B piping with a 0.5 in diameter drilled hole intended to simulate a through-wall defect. The pipe was grit-blasted to a NACE near-white finish prior to the installation of any repairs. One specimen from each of the full-encirclements and the patch repairs was instrumented with strain gages.

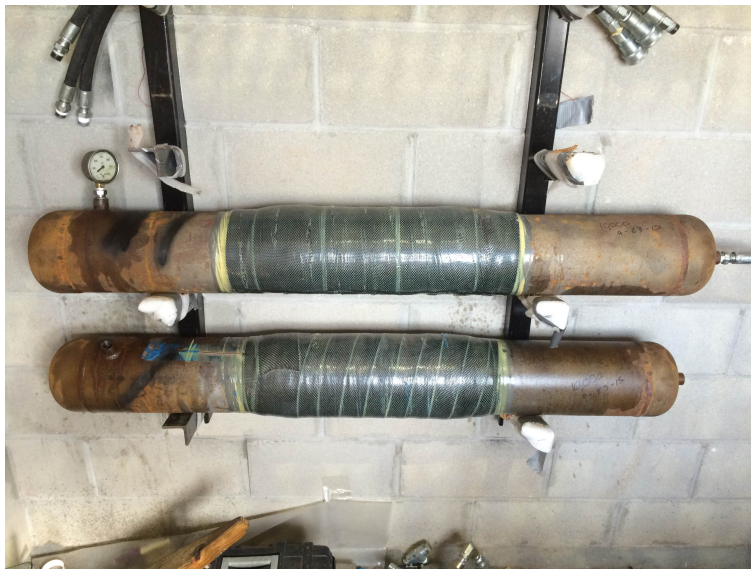
**Figure 2: Picture of full-encirclement repaired pipes in place for fatigue testing.**

A small, custom-designed pressure fatigue testing system was designed around a low-cost, high-pressure water pump. The system was capable of cycling between 0 psi and 1000 psi in approximately 2 seconds. Several safety systems were designed to prevent the accidental over-pressurization of the test specimen. Participating vendors were asked to follow PCC-2 as a minimum when designing the repairs. Additionally, the vendors were asked to maintain the same repair thickness between the patch and the full-encirclement to aid in comparing the performance of the two systems.

then run the instrumented tests of these two vendors. After completing these tests, we will move to the next vendor's samples and expect to fully complete small-scale fatigue testing by the end of November. After completing the testing of the small scale systems, we will contact the vendors and discuss timing and scheduling for installs on the large pressure vessel. A picture of two of the repaired pipes preparing to undergo fatigue testing is shown in Figure 2.

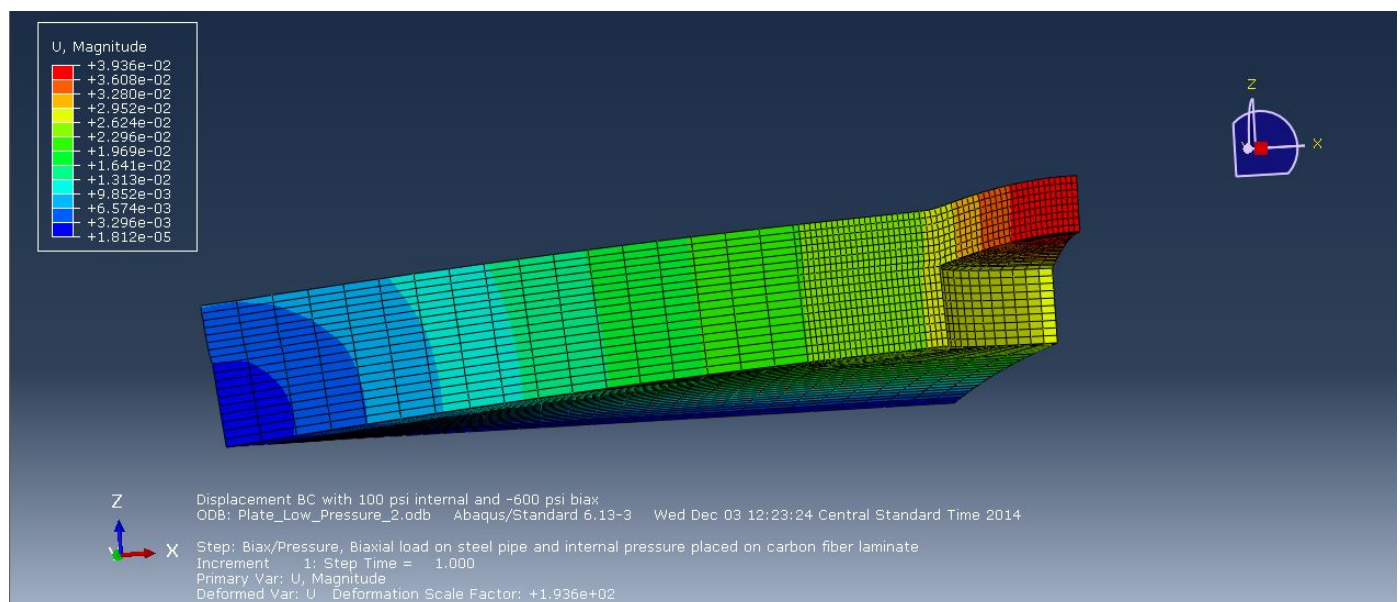
**Figure 3: FEA results of a simulation of a deformable plate with applied repair. Contours represent displacement.**

During this first year, we have been focusing on developing finite element models of the fracture process for the proposed specimens. We expect that these models will help us understand the performance of the through-wall defects under realistic conditions. The primary goal is to allow us to understand the differences between real-world behavior and the analytical predictions in PCC-2. One of the comparisons that we are attempting to make is to compare the performance of a composite blister on a rigid substrate, as assumed in PCC-2, and a blister on a deformable substrate, as in the real repair. To accomplish this comparison, we are attempting to model a deformable flat plate with a repair. A representative simulation is shown below in Figure 5. A direct comparison between the rigid and deformed plate is somewhat complicated, but using the blister edge as a reference, we can plot the profiles of the blister as shown in Figure 4. As expected, the profile for the deformable substrate exhibits overall lower displacement levels, when compared to a rigid substrate. This is due primarily to the flattening tendency of the biaxial tensile stress state that is present in piping. The added complexity of this deformation makes the volume-change approach for calculating interfacial fracture toughness difficult to use, so we investigated a virtual crack closure techniques (VCCT) to help understand the crack tip stress intensity in this more realistic loading scenario.

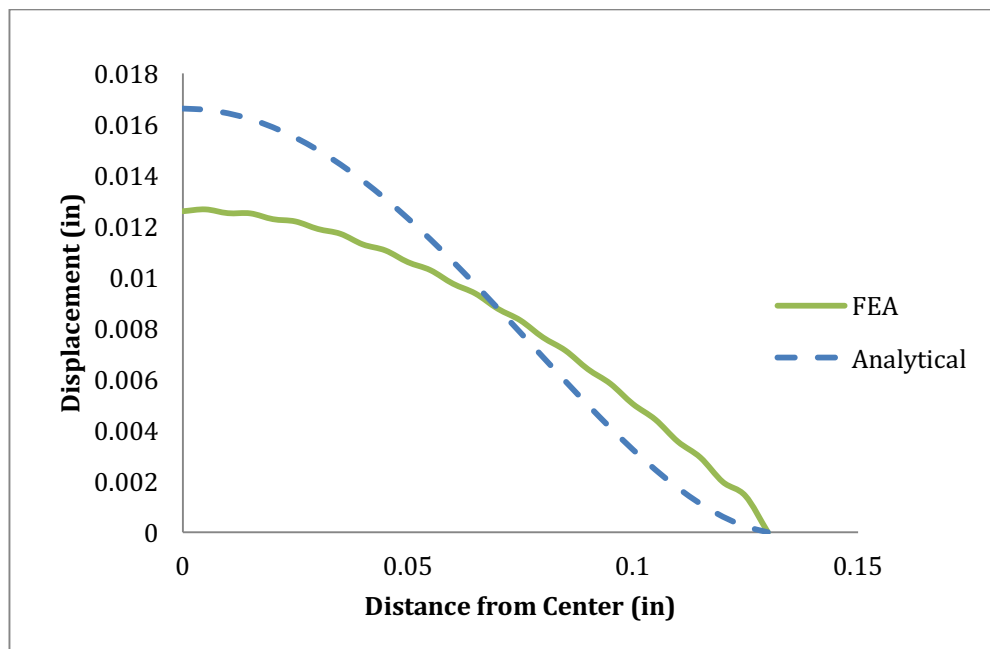
**Figure 4: Comparison of a FEA-predicted blister profile and an analytical profile.**

At the moment, we have suspended the use of VCCT in favor of a simpler strain analysis at the interface. The expectation is that by understanding the stress-strain state of the repair near the interface of the steel/composite at the edge of the hole, we can directly compare the behavior of the patch and full-encirclement repairs. Eventually, the extraction of a fracture-energy parameter will be needed to help design, but if this proves too complicated a strain-based comparison should prove insightful.

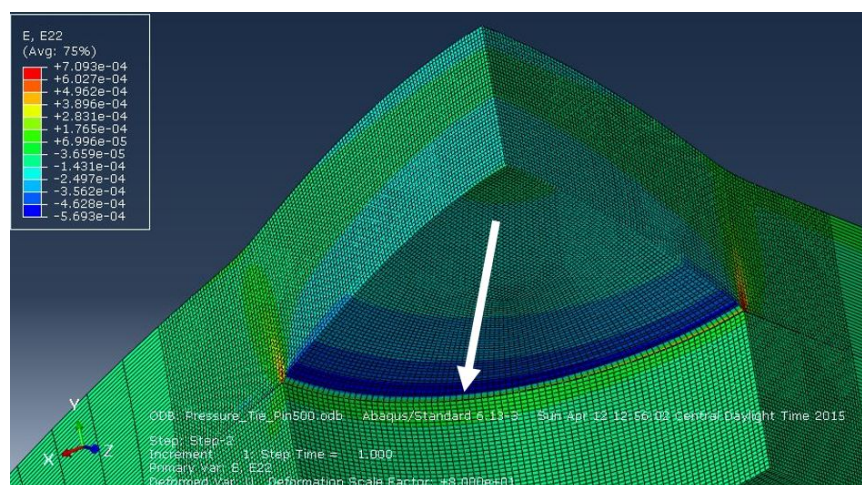
**Figure 5: FEA results of a simulation of a composite repair indicating interface that we are currently studying.**

As discussed above, we have transitioned to a strain-based analysis of the defect and Figure 5 shows a FEA simulation result with a white arrow indicating the interface between the substrate pipe and the composite repair. Strains in the repair were extracted along this line as a stand in for opening forces that tend to drive crack propagation. Figure 7 shows the FEA predicted strains along this interface for a patch and a full encirclement repair. From this data we can see that the patch repair has larger maximum strains when compared to the patch repair. The average strain level is also higher for patch repairs when compared to full encirclements. Based on the deformation of a full-encirclement repair compared to a patch repair, the increase in strain is likely due to increased bending deformation of the base pipe. Increased deformation tends to pull the substrate away from the repair, likely causing the observed increase in opening strains. This result tends to indicate that a patch repair will have relatively poorer performance when compared to the full-encirclement. This has yet to be confirmed with experimental data.

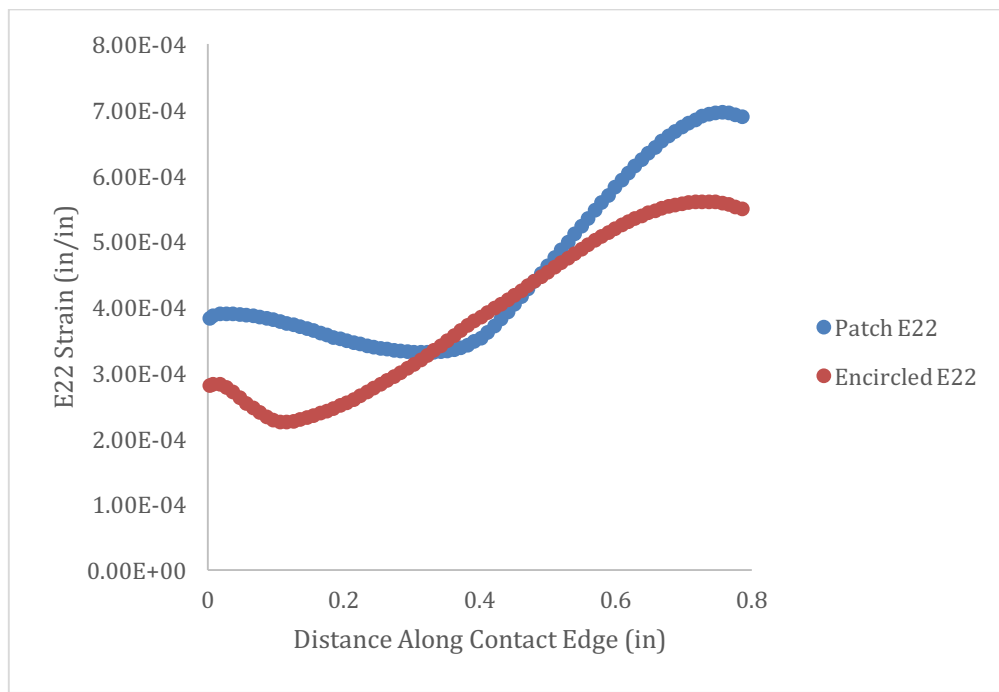
**Figure 6: Comparison of a FEA-predicted opening strain (e22) at the location indicated in Figure 5.**

One of the interesting features of the extracted strains is the peak in the strains shown in Figure 6. We believe that this is due to mesh distortion and is not actually representative of the real stress state. A complete mesh quality and convergence study is underway and we expect that this should clarify if the strain “peaks” are due to anisotropy of the repair or simply distorted elements.

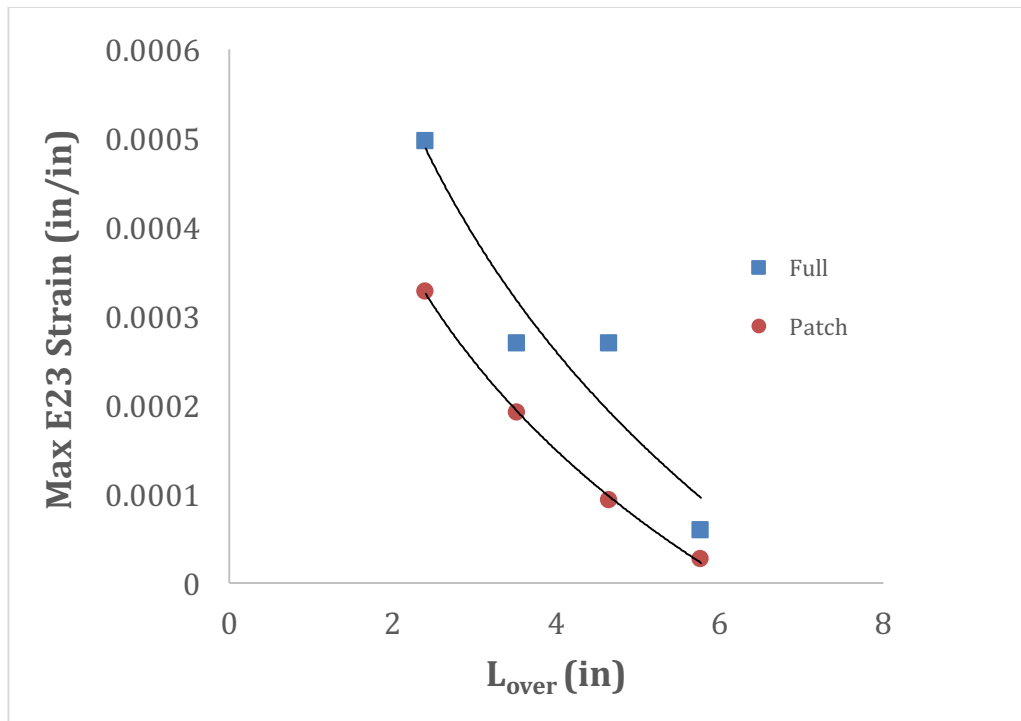
Figure 7: Comparison of interfacial shear strain as a function of extent of repair along the axis of the pressure vessel.

In addition to the investigation of the interfacial opening strains and repair deformation profiles, we have also investigated the impact of repair extent of interfacial shear stress. There are several competing opinions regarding the calculations of the length of the repairs as presented in the ASME PCC2 standard the relevant ISO standard. We performed several simulations where we varied the length of the repair and investigated the in-plane shear strain at the interface of the composite and the substrate.

As seen in previous FEA studies the strain in the patch specimen is actually slightly lower than that of the full-encirclement repairs. In general increasing length of repair reduced the maximum interfacial shear strains rather significantly. This result does tend to lend support to the strain-based calculation of extent of repair as provided in PCC2 and ISO. We are working to understand exactly how critical this length is in ensuring a safe, reliable repair. It is important to note that, even at the shortest lengths, the shear strain values are very low with respect to the maximum failure strain of most composites (0.01 in/in).
